MSAE2018-AMA015

## Study of Penetration Forces by Drilling on Oil Palm Trees

**Paper presented at the 2018 MSAE Conference,  
Serdang, Selangor D. E., Malaysia.  
7 & 8 February 2018**

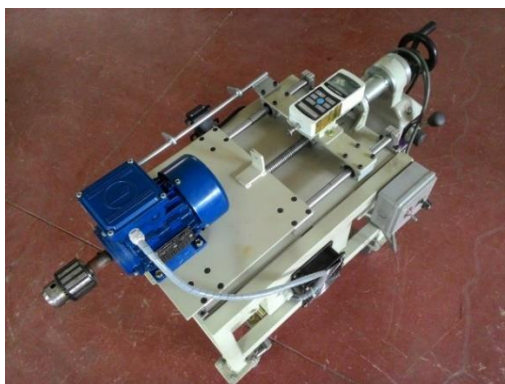
Drilling test was performed by a force gauge attached on fabricated test rig (Figure 1). The test rig was designed to measure penetration force in Newton (N) by manipulating penetration variables such as spindle speed, drilling feed rate, drill bit diameter, drilling angle and drill bit type. The drilling mechanism and the feeder system were integrated into the test rig platform. Drilling mechanism consisted of a drill chuck for holding drill bits from 10 mm to 25 mm bit diameter, and it was driven by a 220 V DC motor connected to a speed controller. The motor could drill at maximum speed of 3000 rpm. While the test rig feeder system was using a linear screw drive system to control force gauge platform motion and hence pushing along the drill platform.

Figure 15: A fabricated test rig

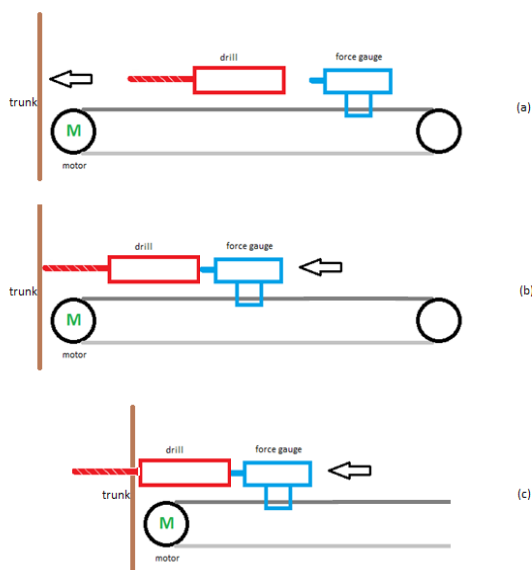
On the test procedure as in Figure 3, test rig was placed horizontally towards the targeted trunk. Then, the drill was moved forward until the drill bit tip was nearly touch on the trunk. Initial position was recorded, and the force gauge reading was in zero. The test was started as feeder motor was switched on and stopped for reaching a desired depth. Drill depth was determined by maximum length for drill bit used for each test. The penetration force was recorded by MESUR™ gauge software.

Figure 3: (a) put drill into initial position as drill tip nearly touch on tree surface, (b) starts to drill tree, and (c) stops as it reaches a certain penetration depth.

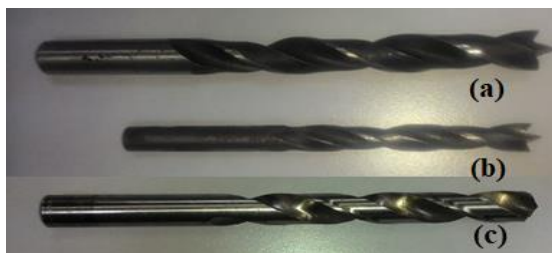
In the drill test, a few parameters were tested to determine the effect relationship on drilling penetration force. Drilling feed speed was fixed at 15 mm/s. Spindle speed, drill bit diameter and drill bit type were the parameters. Two or three variables for each parameter were compared as spindle speed; 1180 rpm, 2250 rpm and 3000 rpm, drill bit diameter; 8 mm and 11 mm, and drill bit type; wood purpose and general purpose (Figure 4). The load comparison between variables were illustrated in graph form. The test parameters are summarized in Table 1.

Figure 4: Drill bit used in the test; (a) 11 mm drill bit for wood purpose, (b) 8 mm drill bit for wood purpose and (c) 8 mm drill bit for general purpose

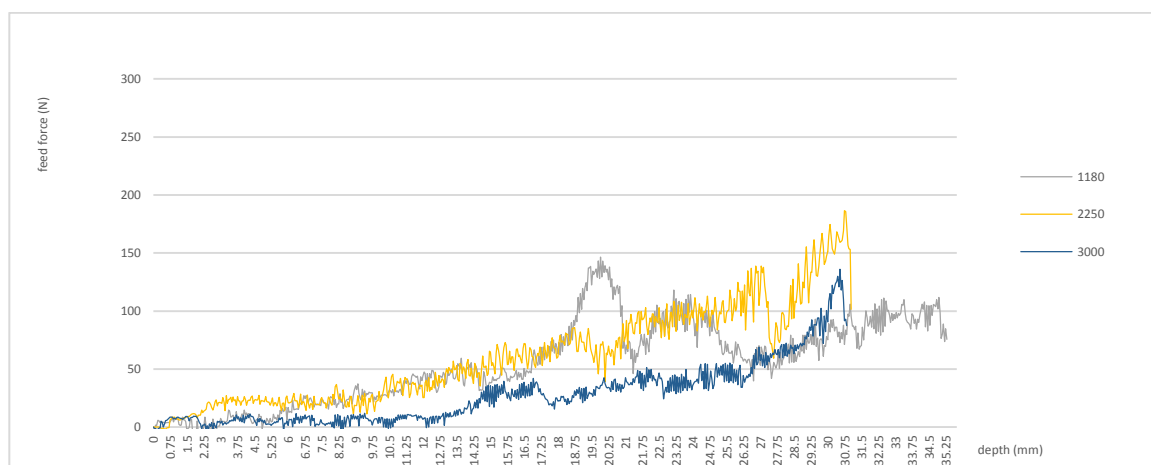
In spindle speed comparison test, 8 mm and 11 mm diameter of drill bit for wood drill purpose were used as fixed variable. Figure 5 shows the spindle speed comparison between 1180 rpm, 2250 rpm and 3000 rpm to penetration force for 8 mm diameter drill bit. Based on the graph, spindle speed at 3000 rpm shows the lowest penetration force (125 N) followed by 2250 rpm (135 N) and 1180rpm (142 N) respectively.

Figure 5: Effect of spindle speed on penetration force for 8 mm diameter of drill bit.
